# LEGIONELLA RISK ASSESSMENT

Hot and Cold Domestic Water Systems

Example Site

21<sup>st</sup> October 2025

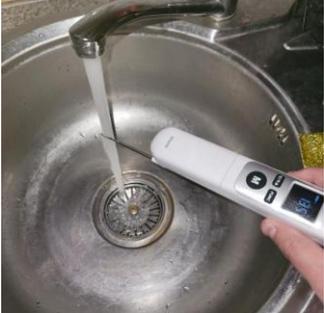
Location	Details	Photo
Ground Floor - Kitchen	Nearest MCWS Cold; Furthest Hot; HOT SOURCE- Hot water Cylinder- indirect, COLD SOURCE- Mains

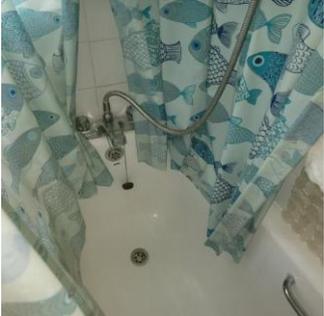
First Floor - Bathroom	Nearest Hot; Nearest TCWS Cold; HOT SOURCE- Hot water Cylinder- indirect, COLD SOURCE- CWST

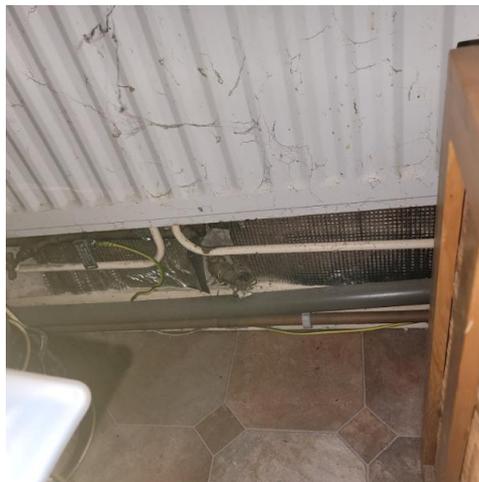
MCWS	
Risk Identifier MCWS	Comment
Location	Ground Floor - Kitchen
Mains water supplied from	Affinity water
Mains water stopcock	Yes
Mains water meter	No
Mains water size	22mm
Incoming supply fitted with a DCV	No
Areas Supplied by Mains Water	Ground floor and CWST
Construction materials WRAS compliant	Yes
Access for pipe work Inspection	No
Pipe work runs direct	Yes
Pipe work insulated	No
Pipe work labelled	No

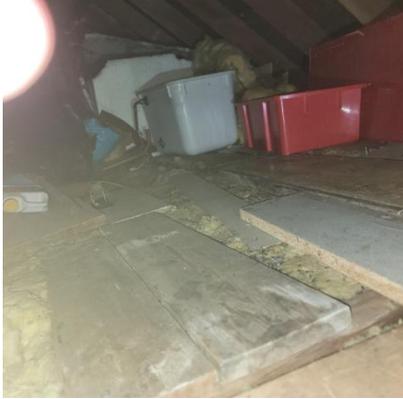
CWST 1

Stored water temperature?	Unknown
Scale	Unknown
Corrosion / Scale	Unknown
Biofilm	Unknown
Sludge / Debris	Unknown
Water Appearance	Unknown
Additional comments	CWST in roof space has poor access, require safe boarding to complete inspection, consider converting to MCWS or move CWST to near the loft hatch

**Install better loft boarding to allow safe inspection**

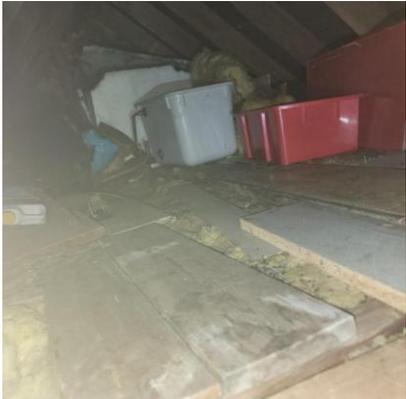
Risk Identifier	Comment/Action
<p><b>Were there any system areas or equipment identified that are not included within the agreed scope of this assessment?</b></p>	<p>No</p>
<p><b>Were there any access restrictions during the assessment?</b></p>	<p>Yes- Unable to access the cold-water storage tank in the roof space due to limited boarding</p>

<p>Second Floor - Attic</p>	<p>Poor access to the CWST, loft boarding required</p>

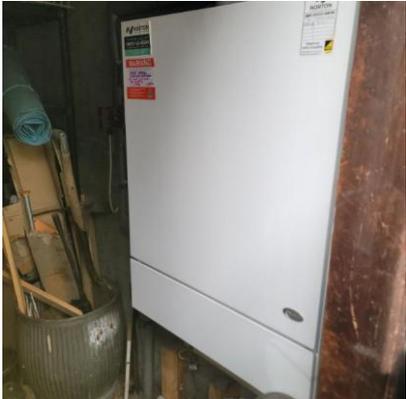
<p>Ground Floor - Kitchen</p>	<p>Oil boiler located in the outside building</p>

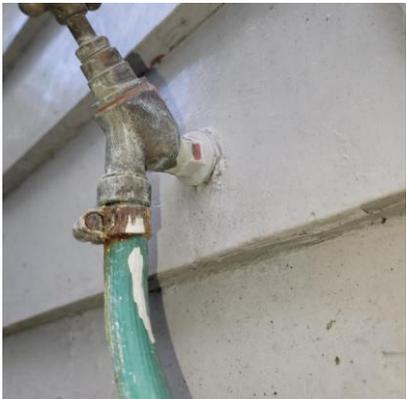
<p>Ground Floor - Outside</p>	<p>No backflow prevention present</p>

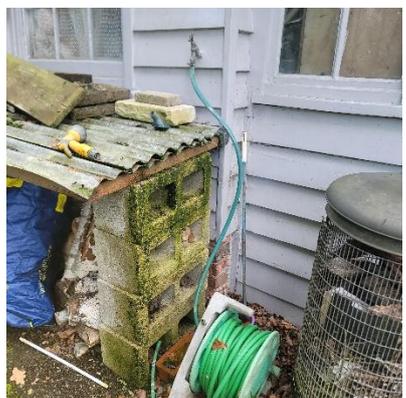
<p>Ground Floor - Outside</p>	<p>The length of hose is approximately 8m</p>

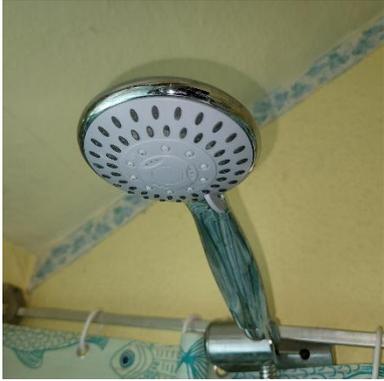
First Floor - Bathroom	Showerhead clean
