# Completion Report Legionella Remedial Works Care Home, Bristol

**Site name:** Care Home, Bristol

**Scope of Works:** Various water system remedial works following recent Legionella risk assessment.

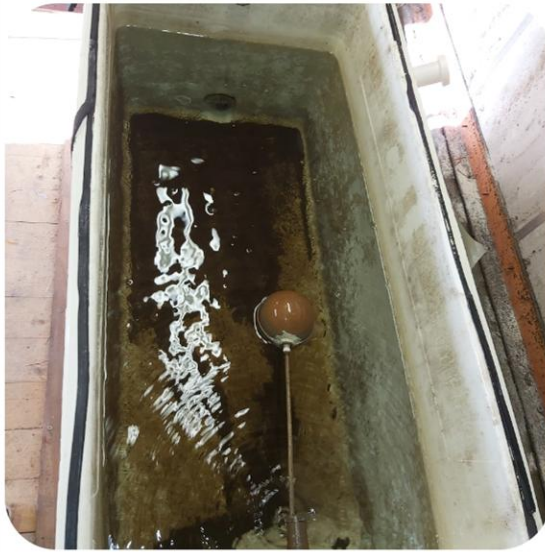
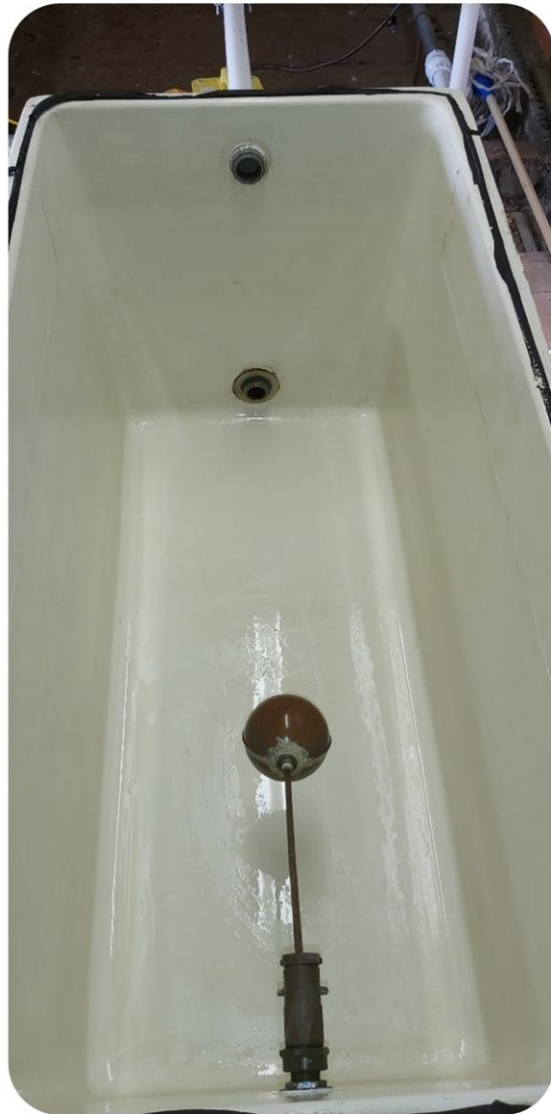
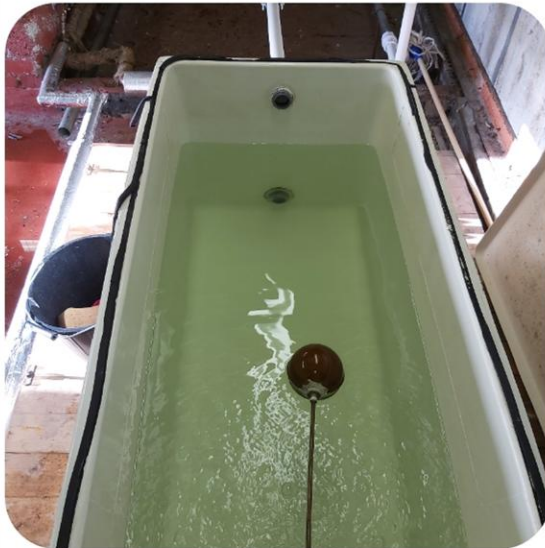
The photo's below show before and after CWST1 was cleaned and disinfected.

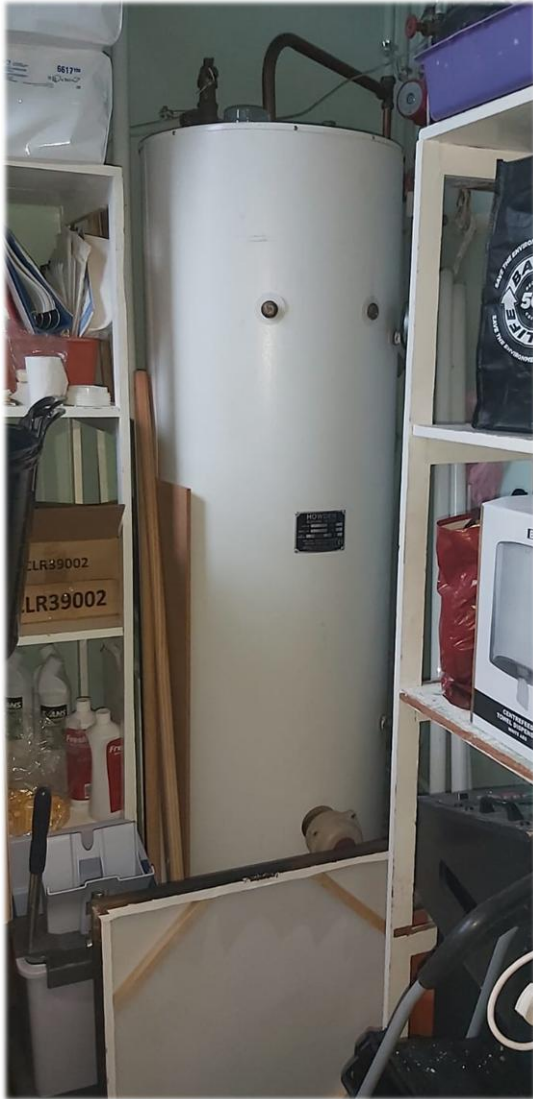
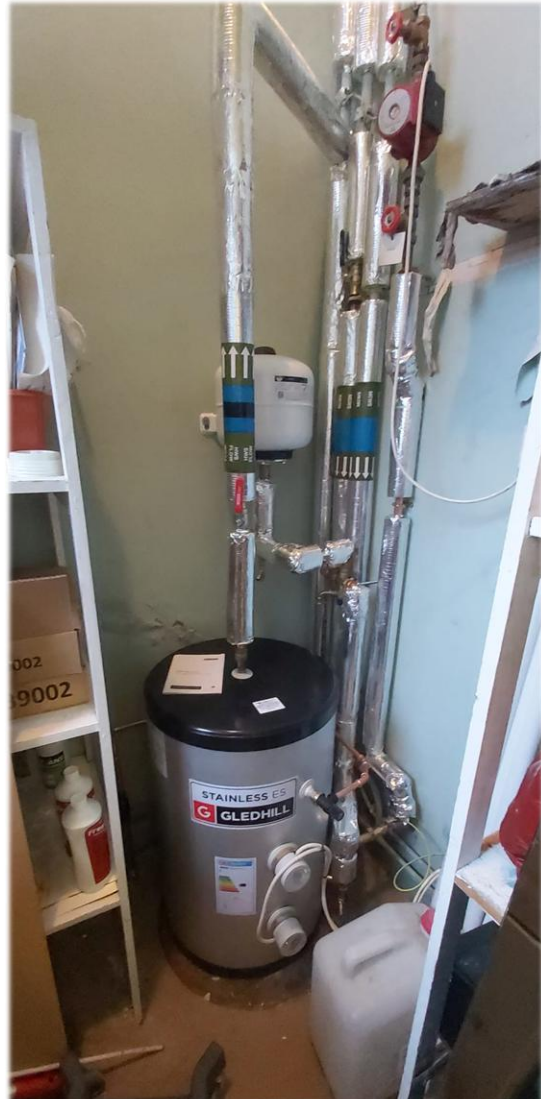
Before and after CAL1 is replaced with new 120L unvented mains fed system:

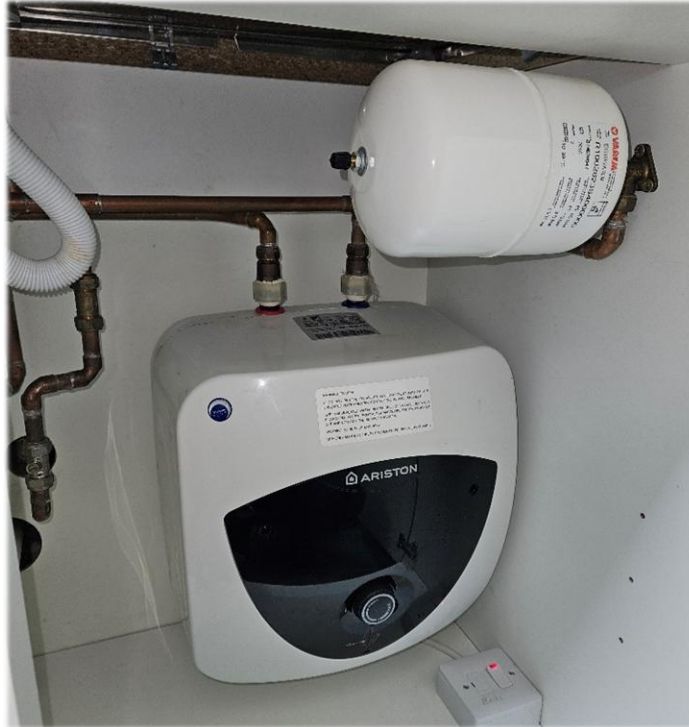
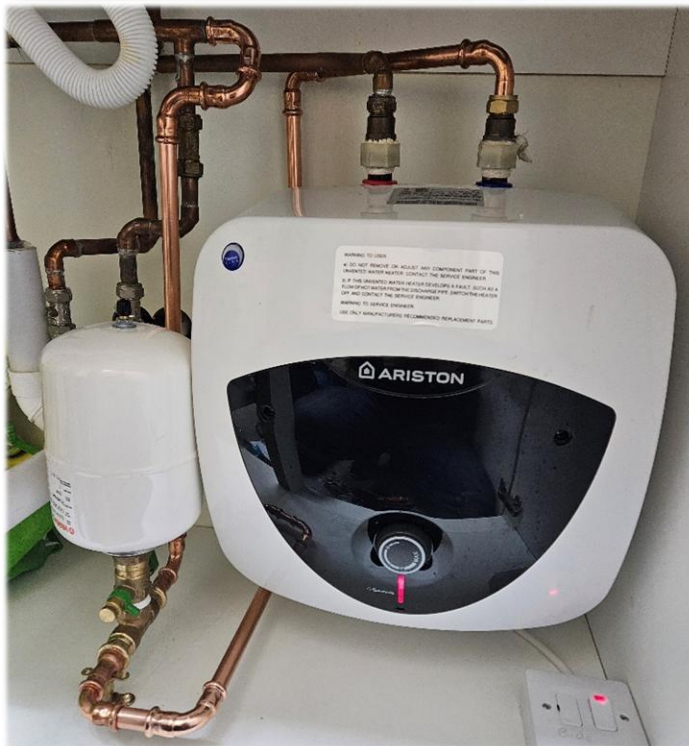
The photo's below show before and after the reorientation of 1no expansion vessel:

- Replace 1no TMV within the disabled WC on the ground floor – **Complete.**
- Reconfigure pipework on an expansion vessel to ensure compliance, including installation of flow through valve – **Complete.**

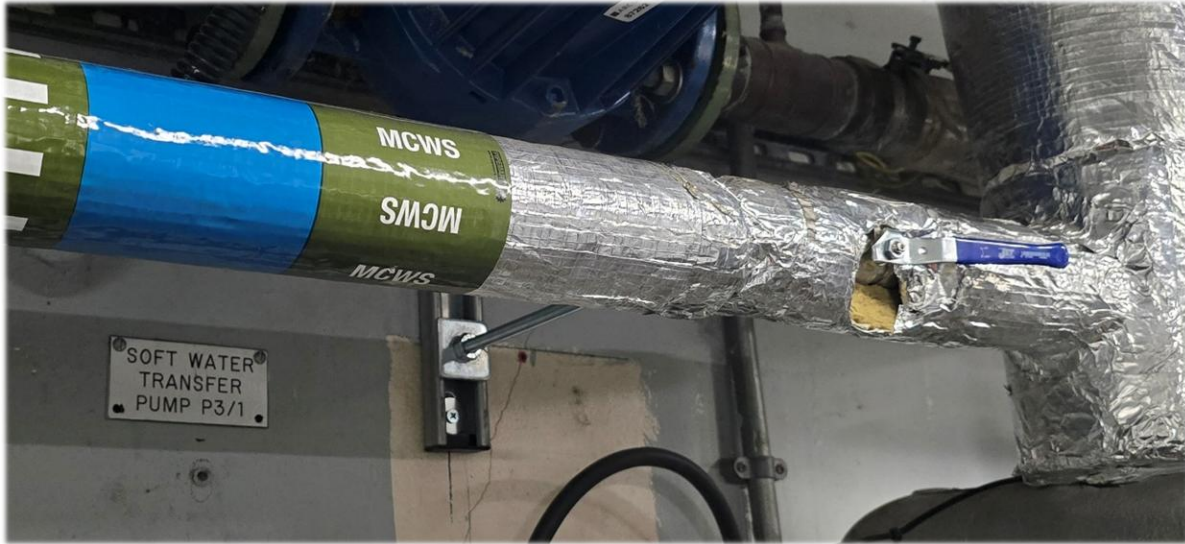
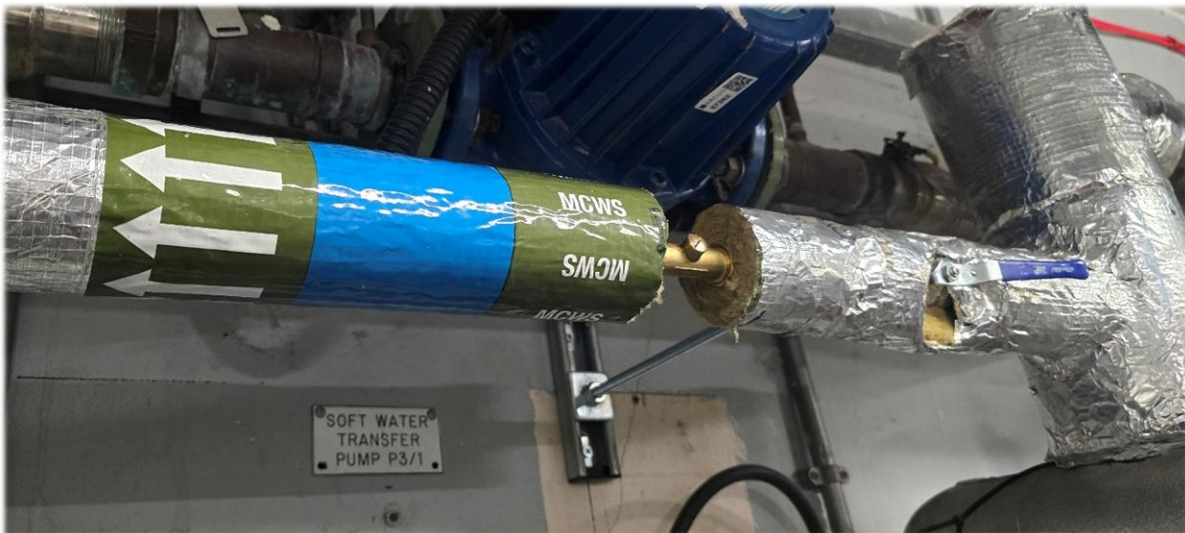
The photos below show an example of before and after 1no double check valve was installed.

- Install a double check valve up to 28mm – **Complete.**
- Insulate all cold-water pipe work – **Complete - 23 meters insulated.**
- Insulate all hot water pipe work – **Not required – All hot pipework has recently been insulated by others.**

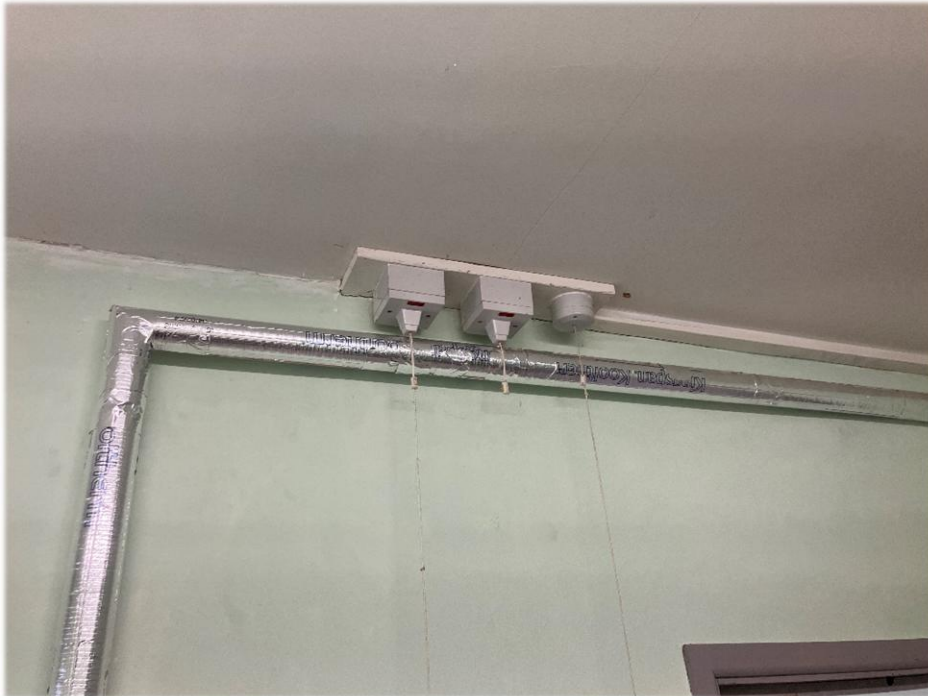
The photo's below show before and after the cold-water pipework was insulated.

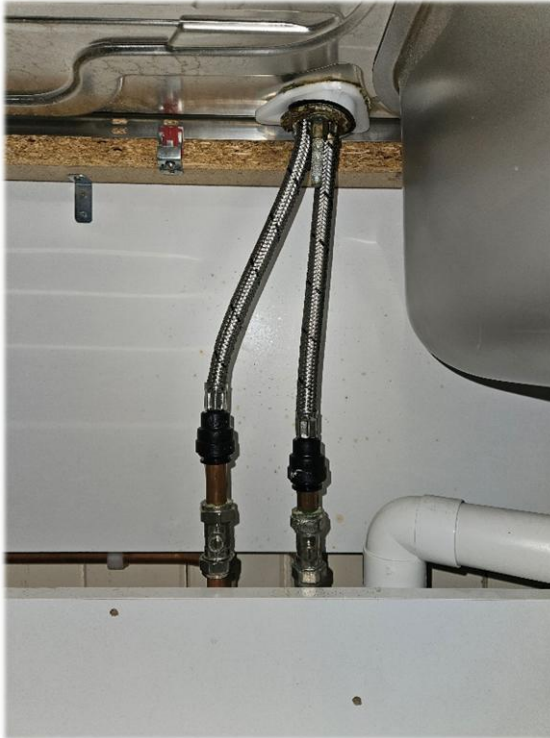
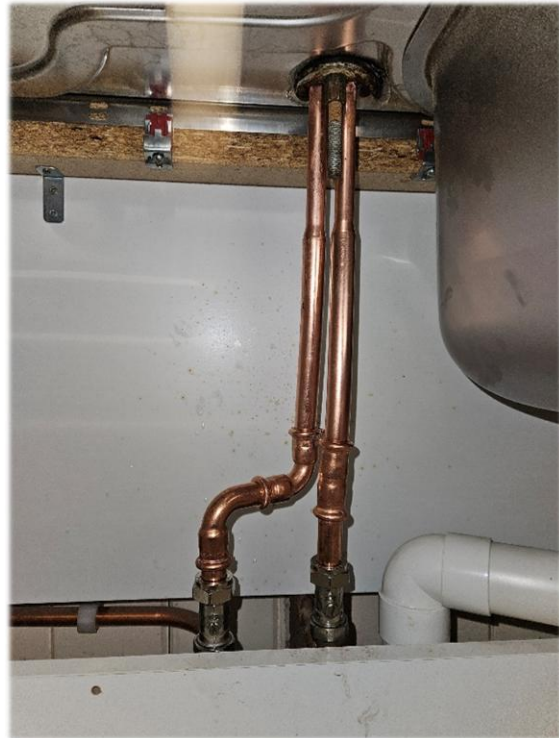
The photos below show before and after 1no pair of non WRAS approved flexible hoses were replaced with copper hard pipe.

- Replace 1no pair of non WRAS approved flexible hoses with copper hard pipe up to 22mm – **Complete.**
- Install gauges on CAL2 to indicate stored, flow and return (where circulated) temperatures – **Not required – New temperature gauges already installed by others.**
