Completion Report Legionella Remedial Works Care Home, Bristol

Site name: Care Home, Bristol

Scope of Works: Various water system remedial works following recent Legionella risk assessment.

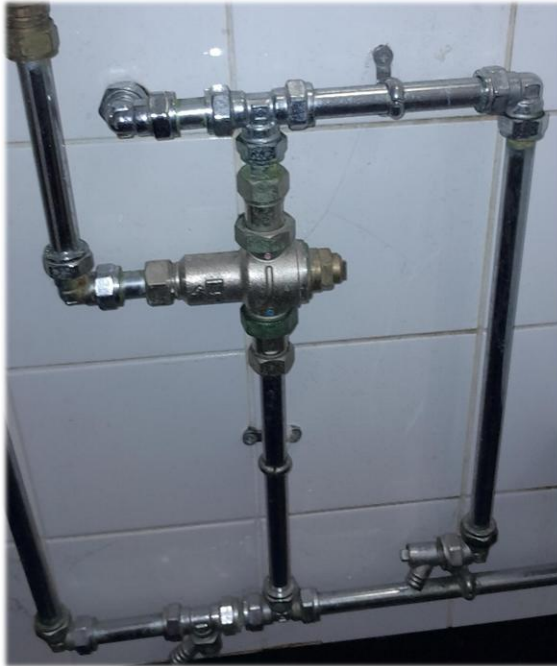
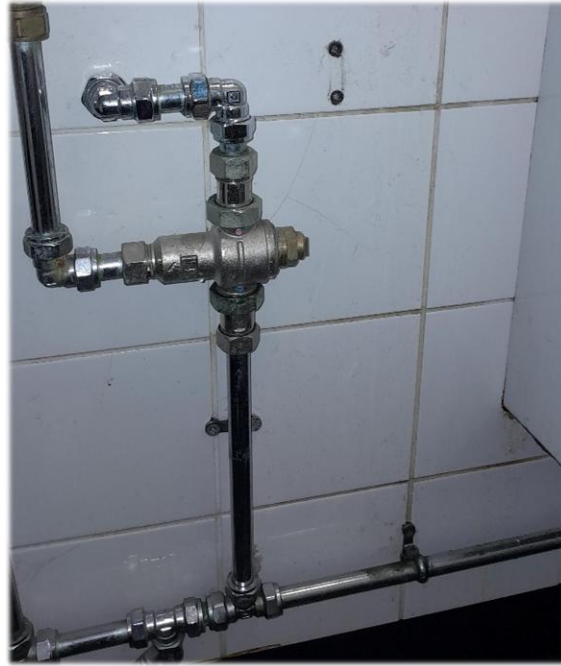
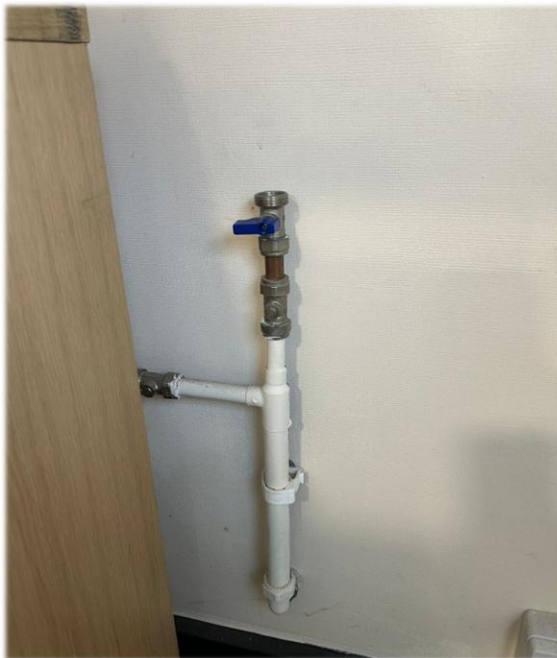
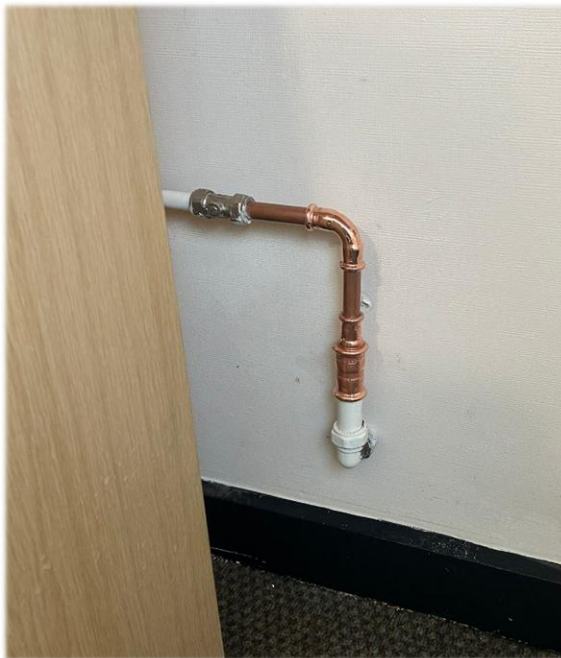
The photos below show before and after 2no dead legs were removed.

- Remove any redundant pipework - **Complete – 2no dead-legs were removed.**
- Complete a clean & disinfect of CWST1 – **Complete.**
- Replace 1no vented cylinder with a new 90L unvented cylinder – **Complete.**

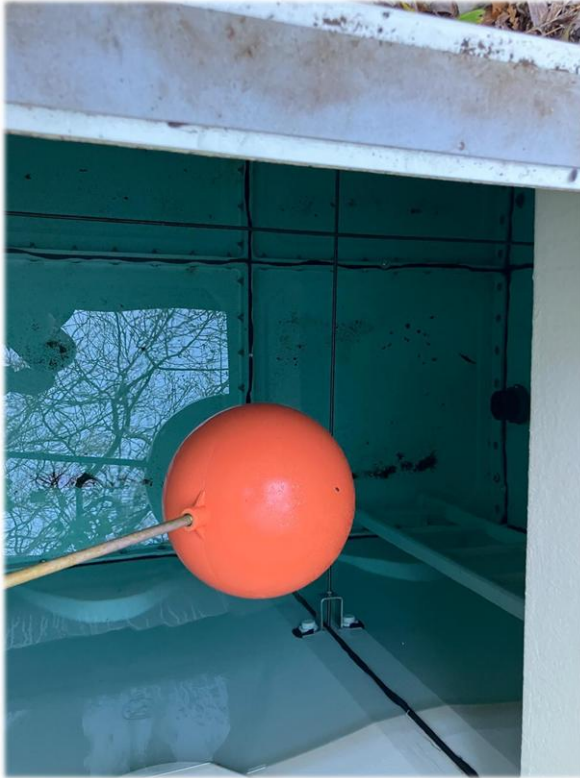
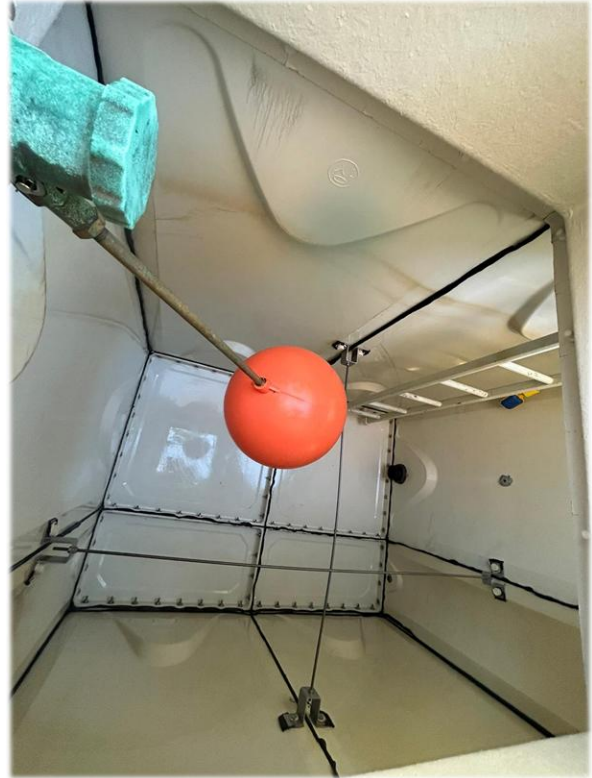
The photo's below show before and after CWST1 was cleaned and disinfected.

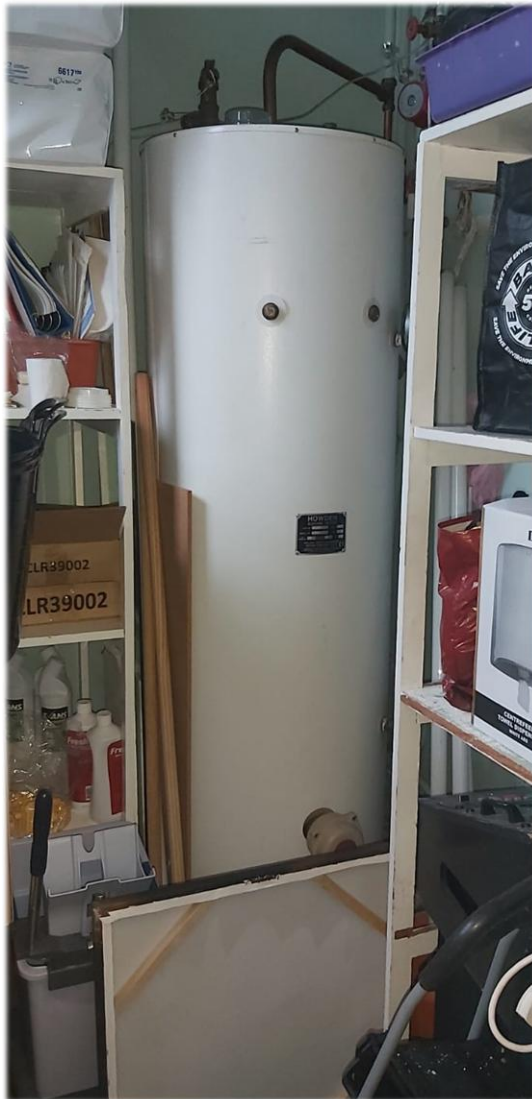
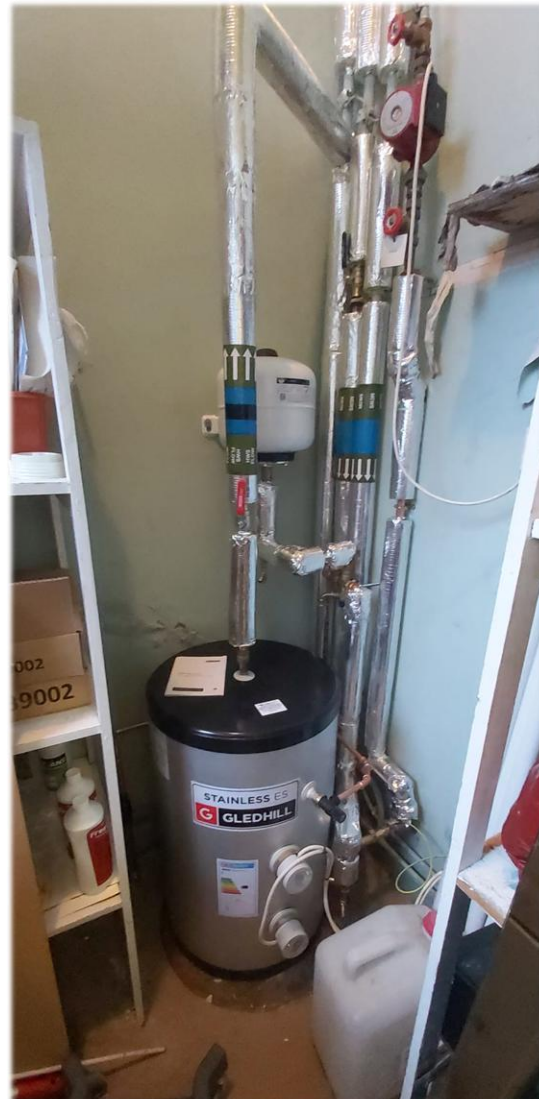
Before and after CAL1 is replaced with new 120L unvented mains fed system:

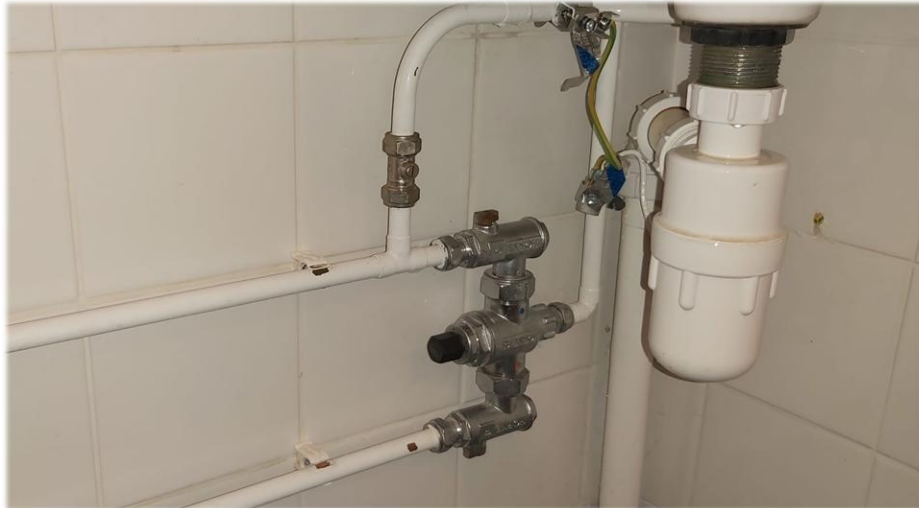
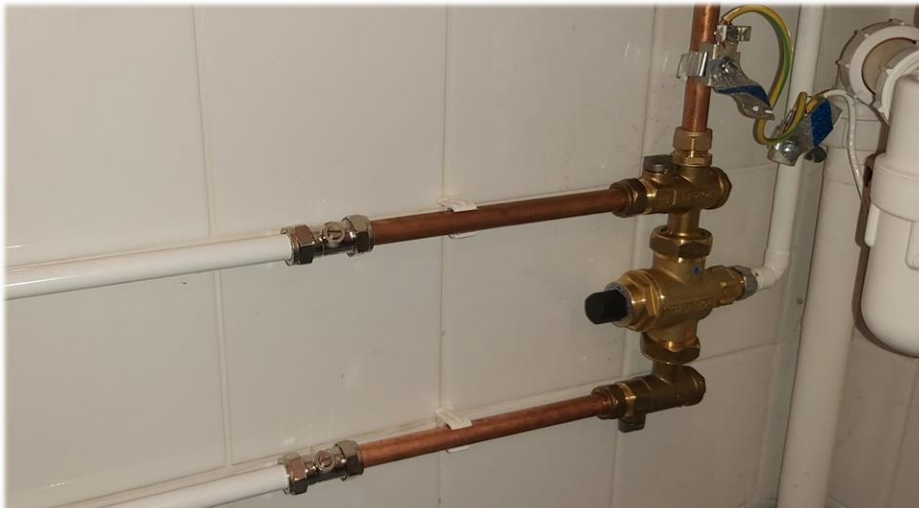
The photos below show before and after 1no TMV was replaced with new.

- Replace 1no TMV within the disabled WC on the ground floor – **Complete.**
- Reconfigure pipework on an expansion vessel to ensure compliance, including installation of flow through valve – **Complete.**

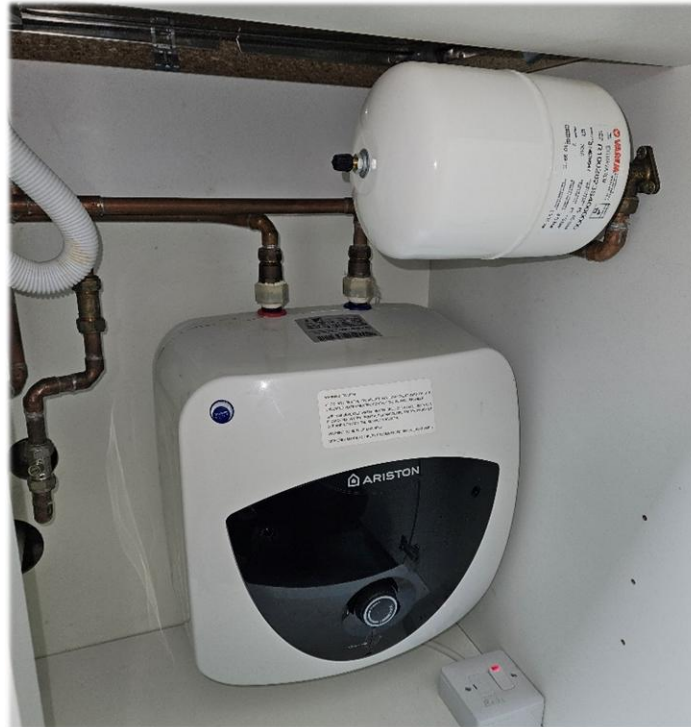
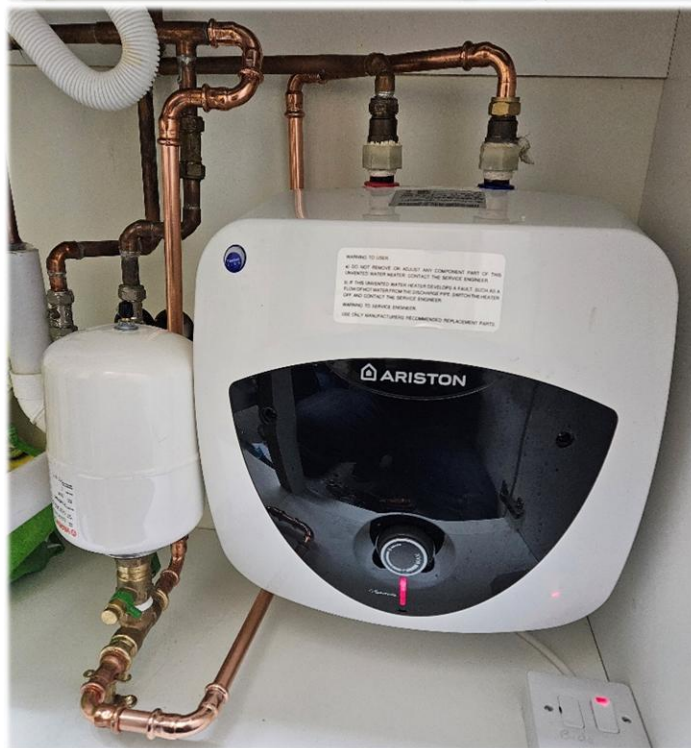
The photo's below show before and after the reorientation of 1no expansion vessel:

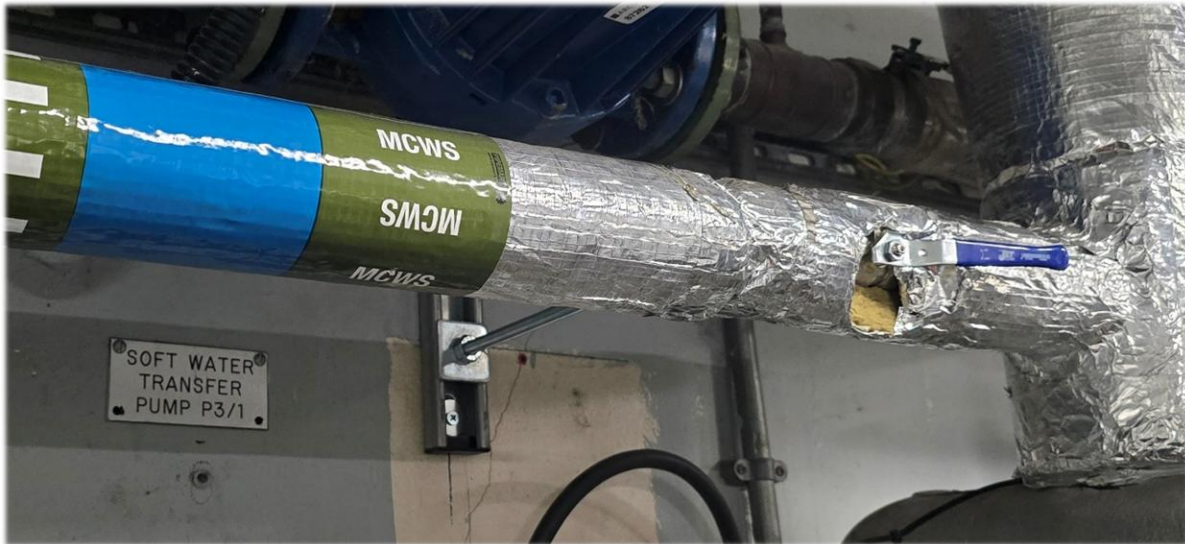
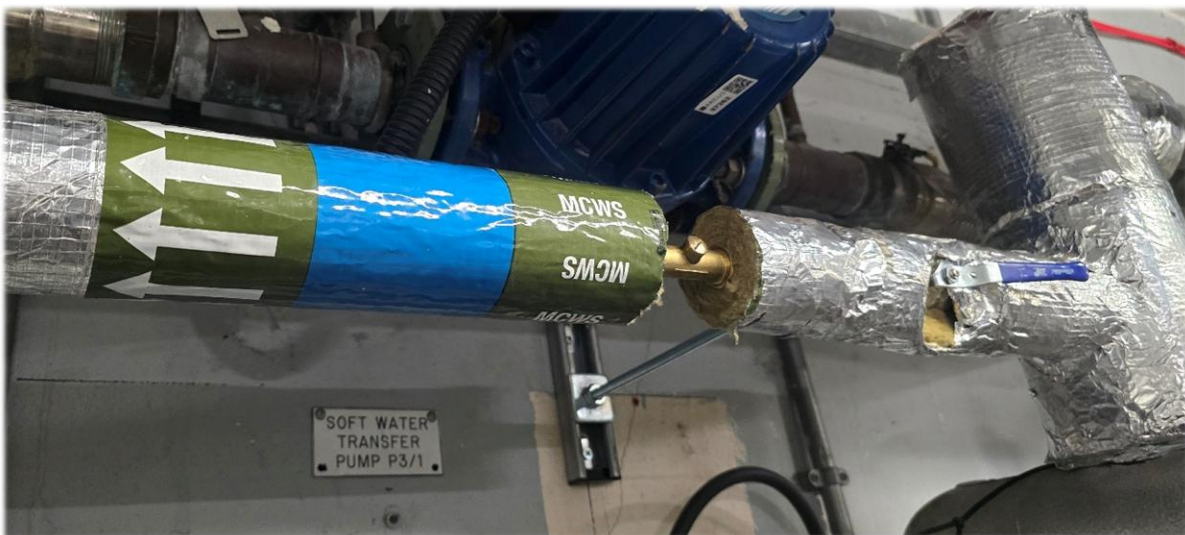
The photos below show an example of before and after 1no double check valve was installed.

- Install a double check valve up to 28mm – **Complete.**
- Insulate all cold-water pipe work – **Complete - 23 meters insulated.**
- Insulate all hot water pipe work – **Not required – All hot pipework has recently been insulated by others.**

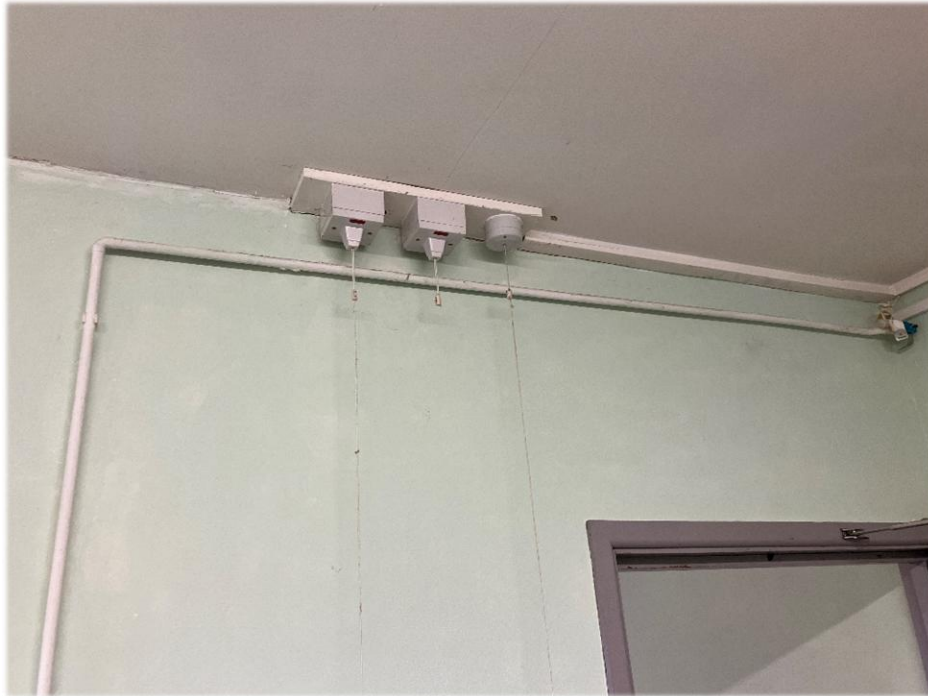
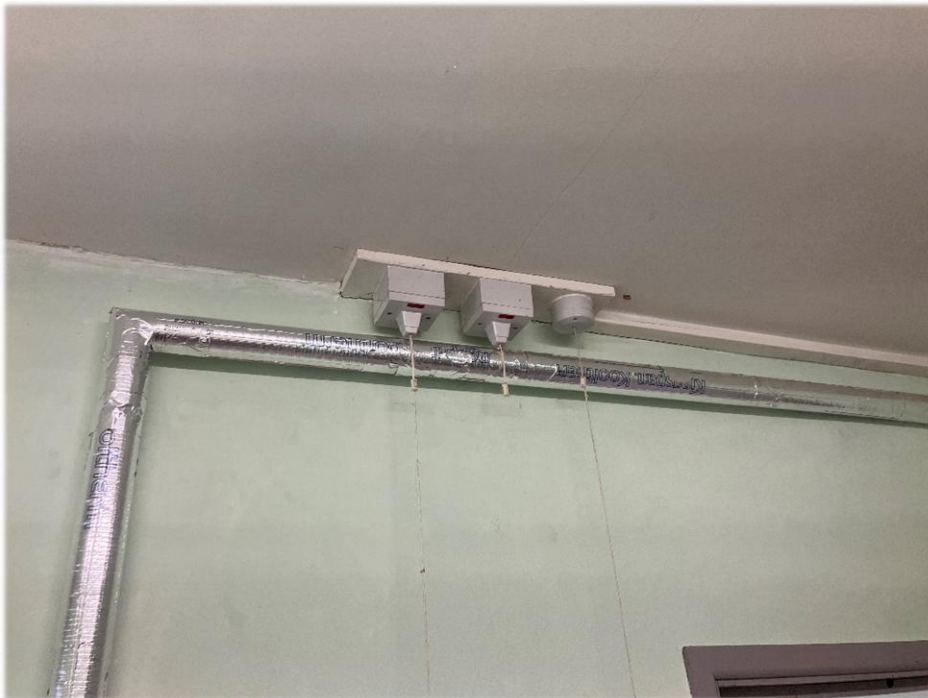
The photo's below show before and after the cold-water pipework was insulated.

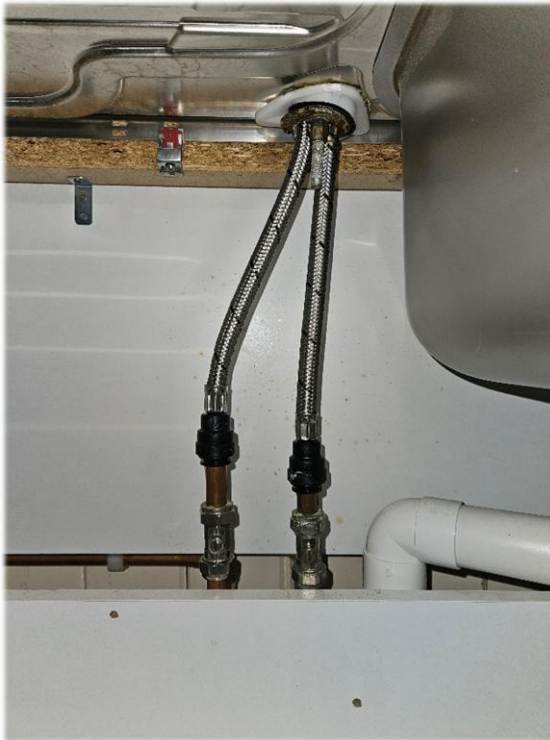
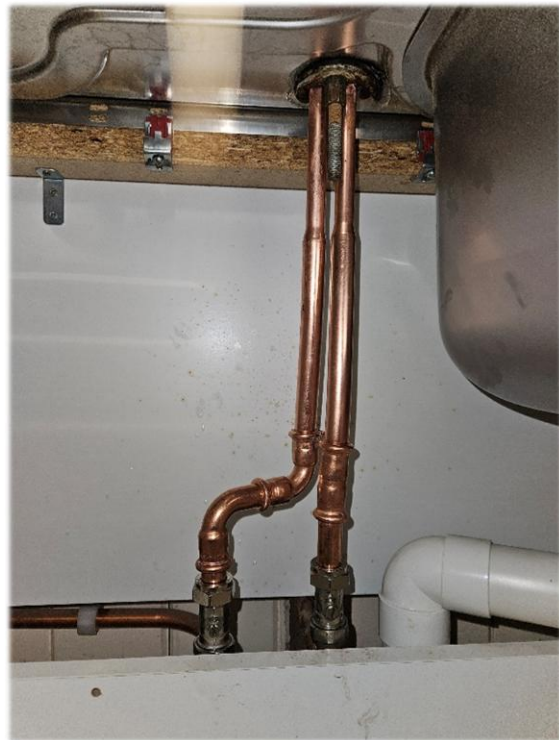
The photos below show before and after 1no pair of non WRAS approved flexible hoses were replaced with copper hard pipe.

- Replace 1no pair of non WRAS approved flexible hoses with copper hard pipe up to 22mm – **Complete.**
- Install gauges on CAL2 to indicate stored, flow and return (where circulated) temperatures – **Not required – New temperature gauges already installed by others.**
